ENGINEERING GEOLOGICAL MAPPING ON SLOPE DESIGN IN THE MOUNTAINOUS AREA OF SABAH WESTERN, MALAYSIA

Rodeano Roslee^{1,2*}, Felix Tongkul^{1,2}

Engineering Geology, Mountainous Area, Slope Design and Sabah Western.

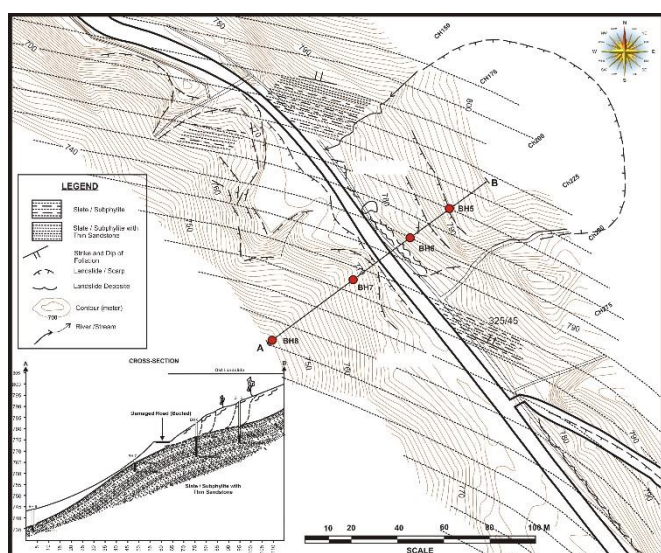
Figure 3: Sketch of slope failure showing the failure movement are starting from the hill side to the road sides through the development of water runoff (Location: SS 4) [22].

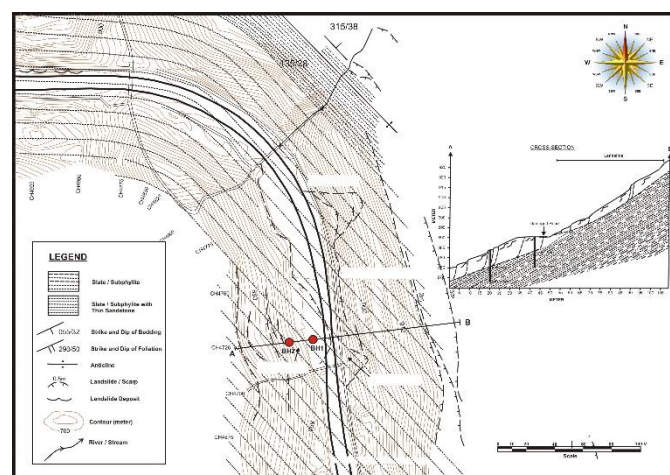
Figure 5: Sketch of slope failure showing the morphological features, which have their whole failure mass is the pear-shaped scar and the presence of an extensive flow features on the lower side of the scar (Location: RS 6)

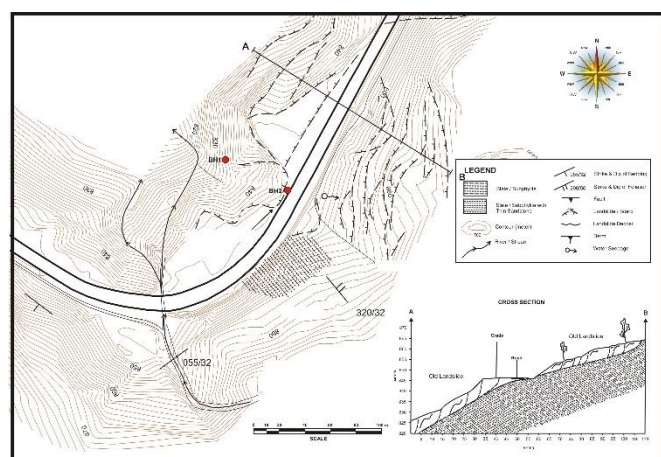
Figure 4: Sketch of slope failure showing the movement pattern is to collapse at the head, fall rapidly within narrow tracks, finally dispersing across the accumulation talus deposits (Location: SS 9) [23].

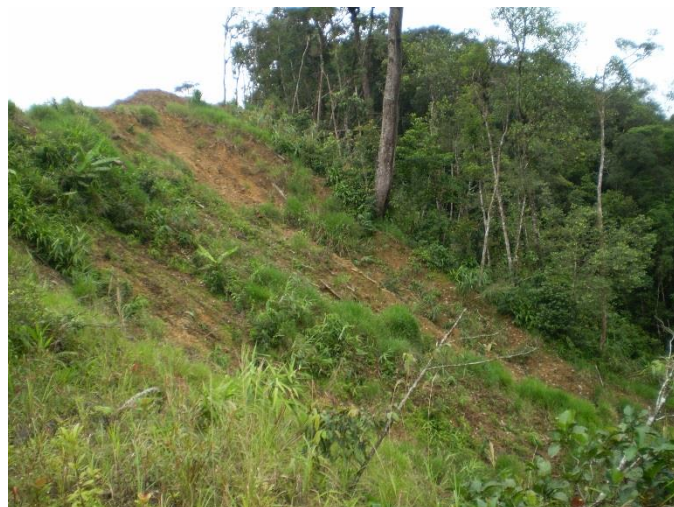
Figure 6: Shallow slide (T1 – a) at SS 1 shows the failure movement are starting to move into several discrete blocks through the development of transverse cracks

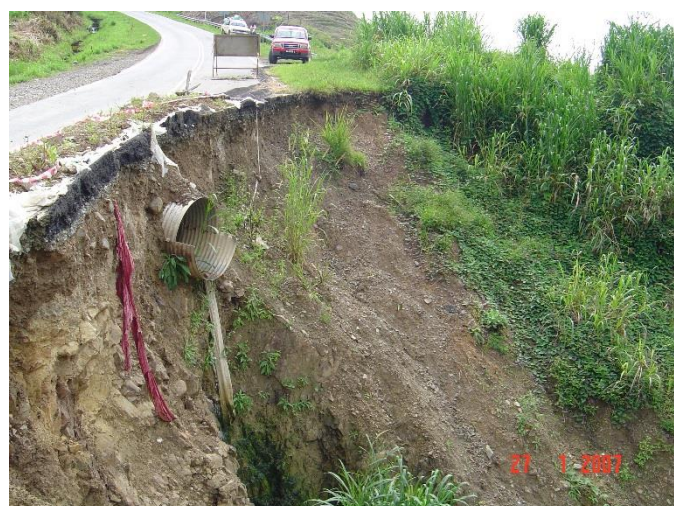
Figure 7: Embankment failure in the form of a deep slide (T1 – b) at SS 6

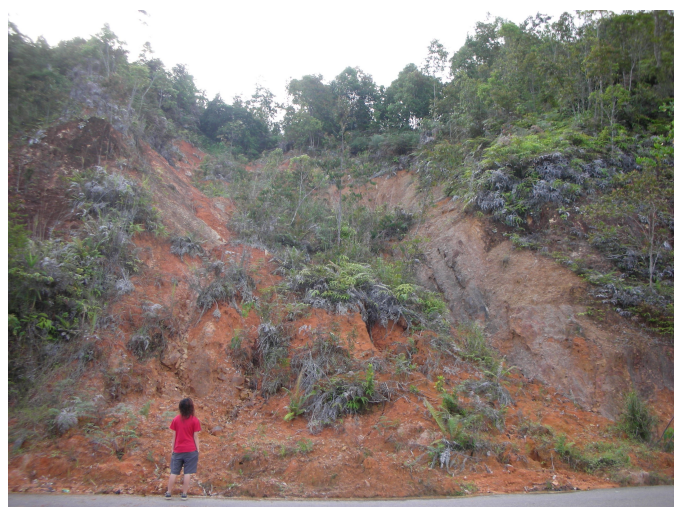
Figure 8: Multiple slump (T2-b) showing the settling slope material suffers from fracturing, stumping or flowing considerable lateral movement along the slip plane of the down slope (Location: SS 8)

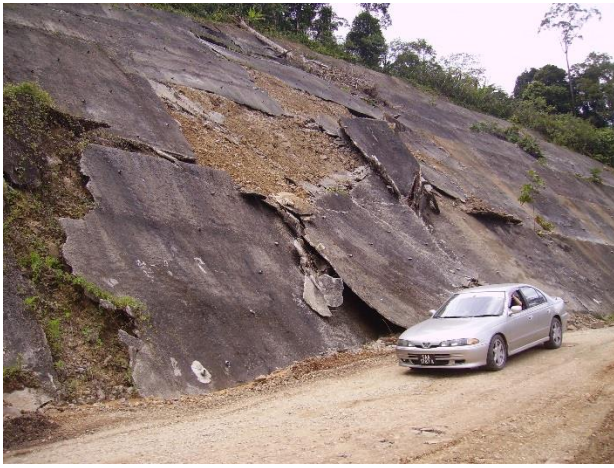
Figure 9: Complex failure (slump flow) (T5 – b) at SS 10) shows the landslide scarp above the road showing the vertical displacement

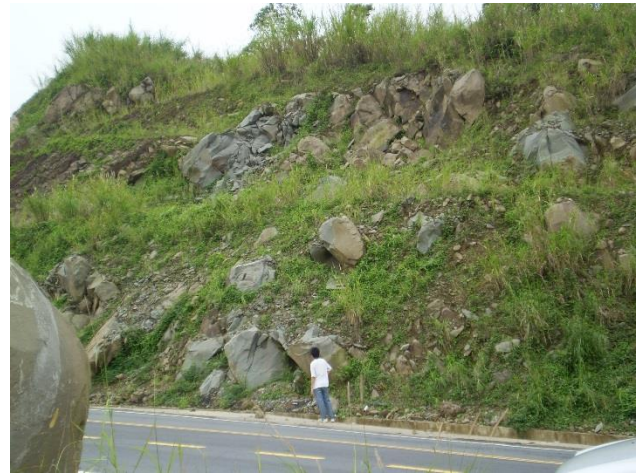
Table 3 shows the results of a detailed analysis of rock slope failures. The main factor contributing to rock slope failures was the orientation and intensity of discontinuity planes (Figures 10 & 11). That is why rock slope failures occur most frequently along the highway on meta-sediment and sedimentary rocks, which were highly brecciated and fractured. Generally the failed material underwent only moderately to completely weathering (grade III to V). The rock properties characterization for 10 rock samples indicated that point load strength index ranges from 0.30 MPa to 0.48 MPa (moderately weak). Kinematics slope analyses indicates that the variable potential of circular, planar, wedges and toppling failures modes as well as the combination of more than one mode of aforementioned failure. Rock slopes stability analysis indicates that the factor of safety value as unsafe (0.68 to 0.92). Other factors contributing to rock slope failure are the presence of groundwater, climatological setting, joints filling material, high degree of rock fracturing due to shearing, steep of slope angle, high intensive of faulting and folding activities and locating at the fault zones area.

Figure 10: Circular failure (crushed) (B1 – b) at RS 10 shows the surface weakness (revealing) within the structure, which composed of coherent crushed rocks on the gently sloping discontinuities
